Transmission Loss Plot (Integrity Gaskets)

Solutions for living life quietly

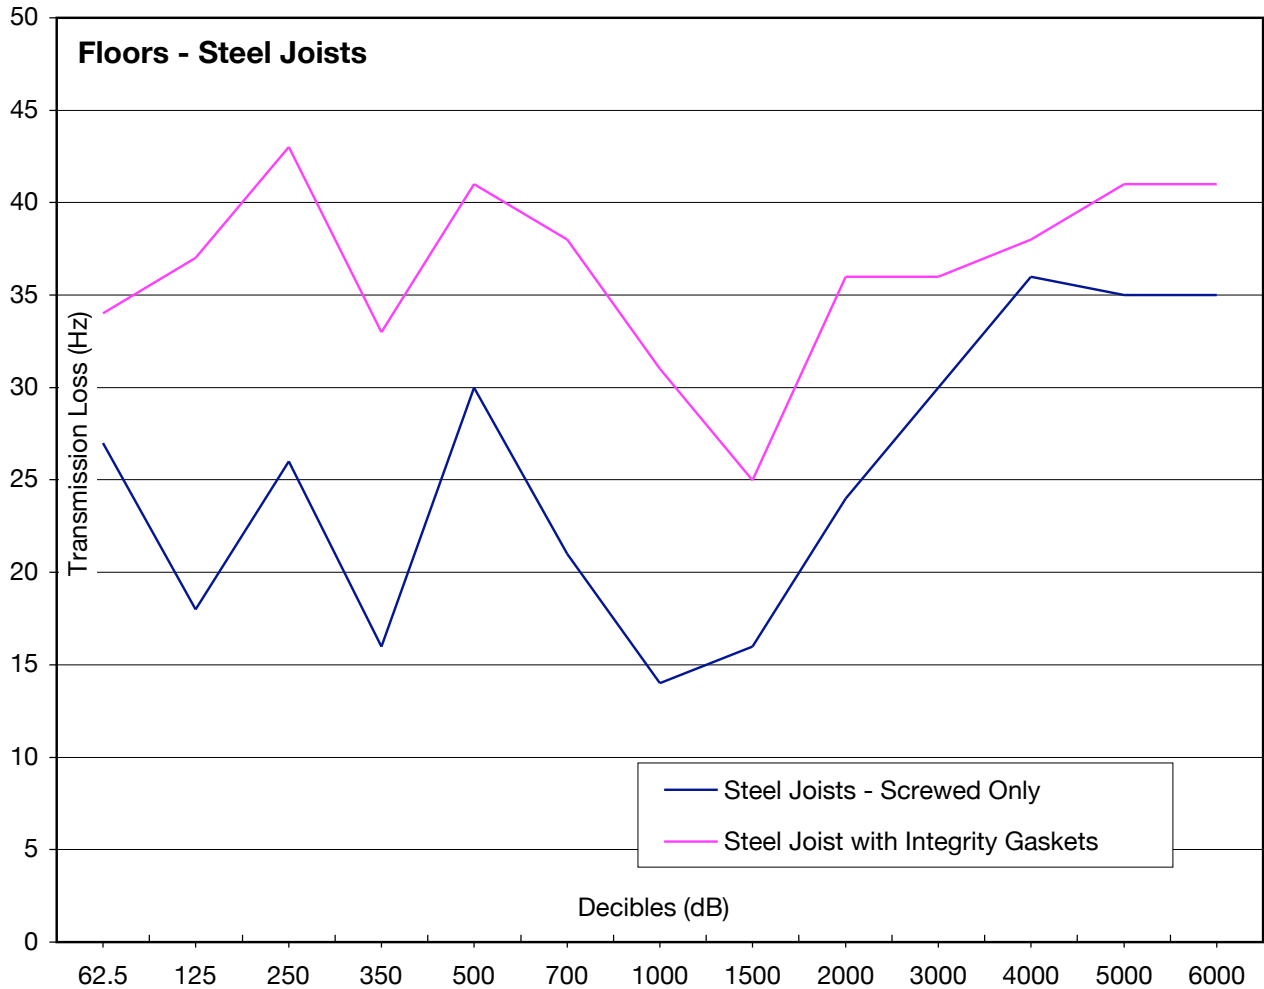
The chart below illustrates the amount of dB deflected from source room to receiving room. Source room sounds generated in the rooms were very loud, in the 100-110 dB range. Levels on the receiving side ranged from 60 dB to as high as 88 dB, depending on the tone frequency input, music input and on the resonant frequencies of some structural components. Tabulated test results follow.

Frequency	62.5	125	250	350	500	700	1000	1500	2000	3000	4000	5000	6000	2000	2500	3150	4000	5000
Steel Joists - Screwed Only	27	18	26	16	30	21	14	16	24	30	36	35	35	38	40	42	43	43
Steel Joist with Integrity Gaskets	34	37	43	33	41	38	31	25	36	36	38	41	41	34	35	36	37	37
Improvement with Integrity Gaskets	7	19	16	17	11	17	17	9	12	6	2	6	6	34	35	36	37	37

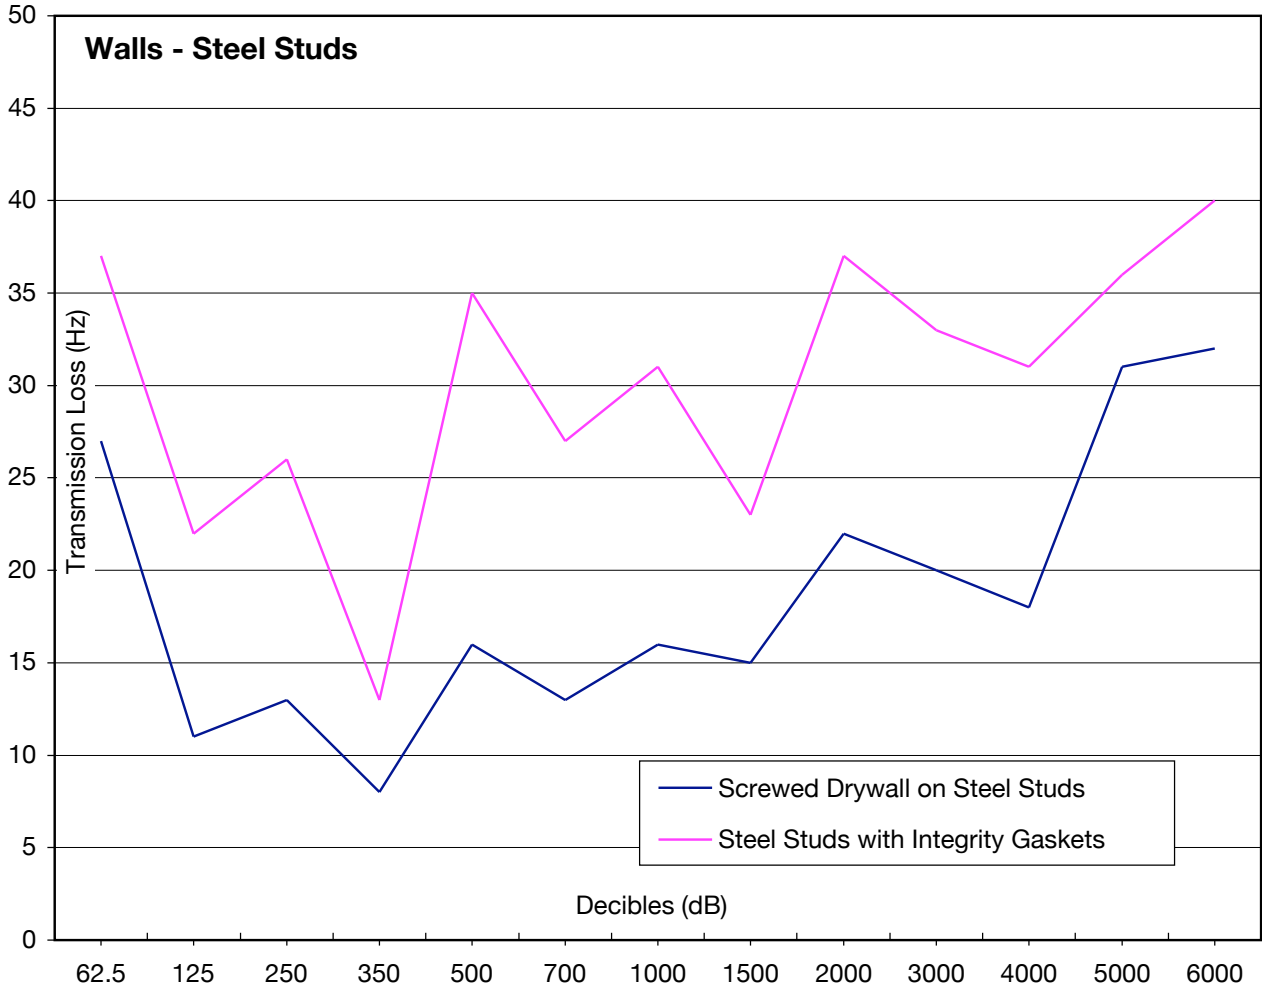
Transmission Loss Plot (Integrity Gaskets)

The chart below illustrates the amount of dB deflected from source room to receiving room. Source room sounds generated in the rooms were very loud, in the 100-110 dB range. Levels on the receiving side ranged from 60 dB to as high as 88 dB, depending on the tone frequency input, music input and on the resonant frequencies of some structural components. Tabulated test results follow.

Frequency	62.5	125	250	350	500	700	1000	1500	2000	3000	4000	5000	6000	2000	2500	3150	4000	5000
Screwed Drywall on Steel Studs	27	11	13	8	16	13	16	15	22	20	18	31	32	38	40	42	43	43
Steel Studs with Integrity Gaskets	37	22	26	13	35	27	31	23	37	33	31	36	40	34	35	36	37	37
Improvement with Integrity Gaskets	10	11	13	5	19	14	15	8	12	13	3	5	8	34	35	36	37	37

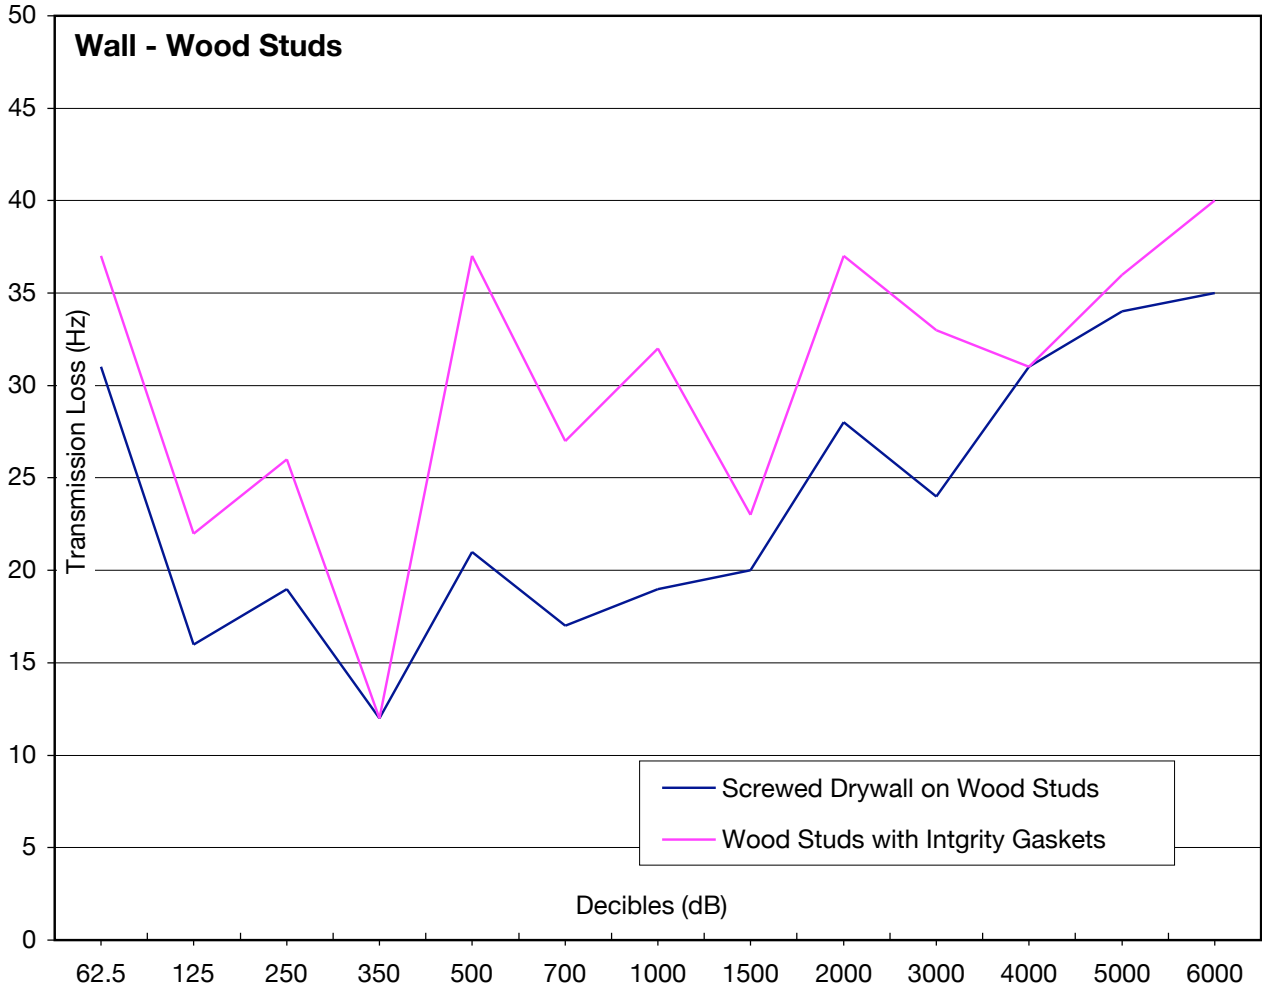
Transmission Loss Plot (Integrity Gaskets)

The chart below illustrates the amount of dB deflected from source room to receiving room. Source room sounds generated in the rooms were very loud, in the 100-110 dB range. Levels on the receiving side ranged from 60 dB to as high as 88 dB, depending on the tone frequency input, music input and on the resonant frequencies of some structural components. Tabulated test results follow.

Frequency	62.5	125	250	350	500	700	1000	1500	2000	3000	4000	5000	6000	2000	2500	3150	4000	5000
Screwed Drywall on Wood Studs	31	16	19	12	21	17	19	20	28	24	31	34	35	38	40	42	43	43
Wood Studs with Integrity Gaskets	37	22	26	12	37	27	32	23	37	33	31	36	40	34	35	36	37	37
Improvement with Integrity Gaskets	6	6	7	0	16	10	13	3	9	9	0	2	5	34	35	36	37	37
